Contract #: 04-0120F4Cty: SF/ALA Rte: 80 PM: 13.2/13.9File #: 1.28**WELDING INSPECTION REPORT****Resident Engineer:** Casey, William**Address:** 333 Burma Road**City:** Oakland, CA 94607**Report No:** WIR-027736**Date Inspected:** 09-Jun-2012**Project Name:** SAS Superstructure**OSM Arrival Time:** 700**Prime Contractor:** American Bridge/Fluor Enterprises, a JV**OSM Departure Time:** 1530**Contractor:** American Bridge/Fluor Enterprises, a JV**Location:** Job site**CWI Name:** As Noted Below**CWI Present:** Yes No**Inspected CWI report:** Yes No N/A**Rod Oven in Use:** Yes No N/A**Electrode to specification:** Yes No N/A**Weld Procedures Followed:** Yes No N/A**Qualified Welders:** Yes No N/A**Verified Joint Fit-up:** Yes No N/A**Approved Drawings:** Yes No N/A**Approved WPS:** Yes No N/A**Delayed / Cancelled:** Yes No N/A**Bridge No:** 34-0006**Component:** OBG/Tower**Summary of Items Observed:**

Tower (ESW Repairs)

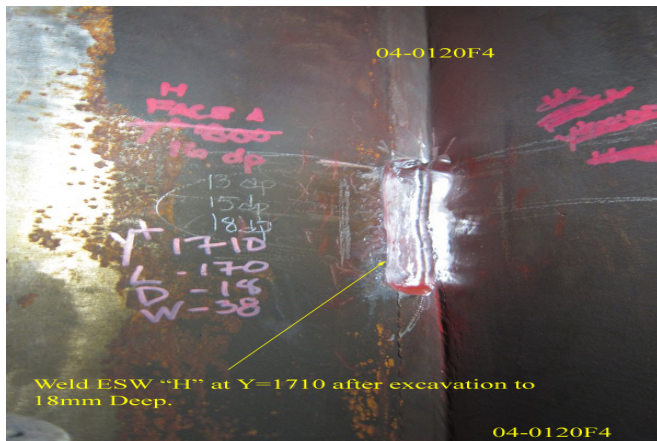
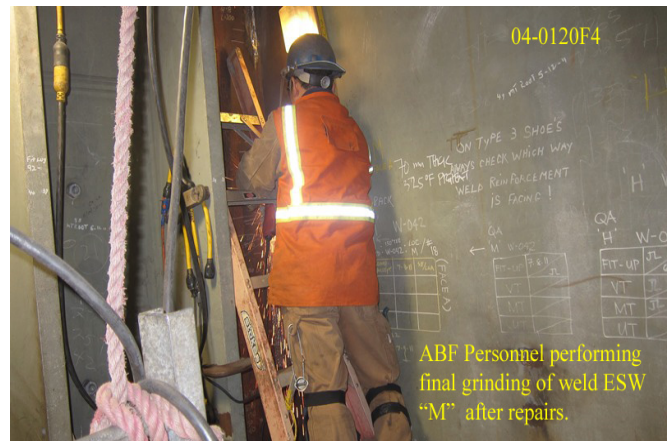
This QA inspector observed ABF/JV personnel performing the final grinding of weld reinforcement for weld ESW "E" from face "B". The Y location of the repair was noted as Y= 6645~7640. The welding of this location was completed on the previous shift. The ABF QC Inspector Ted Elo was present in order to monitor the progression of work.

This QA noted and periodically observed ABF/JV welding personnel performing excavation of weld ESW "H" previously rejected by Ultrasonic Testing (UT). The Quality Control (QC) Inspector Jesse Cayabyab performed Magnetic Particle (MT) and visual confirmation of excavations. The QC observed rejectable indications at the time of testing and instructed the welding personnel to continue until they were no longer present. Excavations have been recorded and are to be submitted to engineer for further review. The Y location of the weld repair is Y=1710, Length 170 and was excavated to a depth of 18mm.

This QA inspector observed ABF/JV personnel performing the final grinding of weld reinforcement for weld ESW "M" from face "A". The Y location of the repair was noted as Y= 8240~8770. The welding of this location was completed on the previous shift. The ABF QC Inspector Bernard Docena was present in order to monitor the progression of work.

This QA inspector observed ABF/JV personnel performing the final overhead grinding operations of the lift 13 East deck weld reinforcement that was welded on an earlier shift. The QC inspector Salvador Merino was present in order to monitor the progression of work inspecting the grinding at the weld toe to ensure sufficient blending prior to final UT and MT inspection.
